# **Gear Corrosion During the Manufacturing Process**

By O. El-Saeed and G. Sroka,  
REM Chemicals, Inc. and  
G. Blake, Rolls-Royce  
Corporation

## **Abstract**

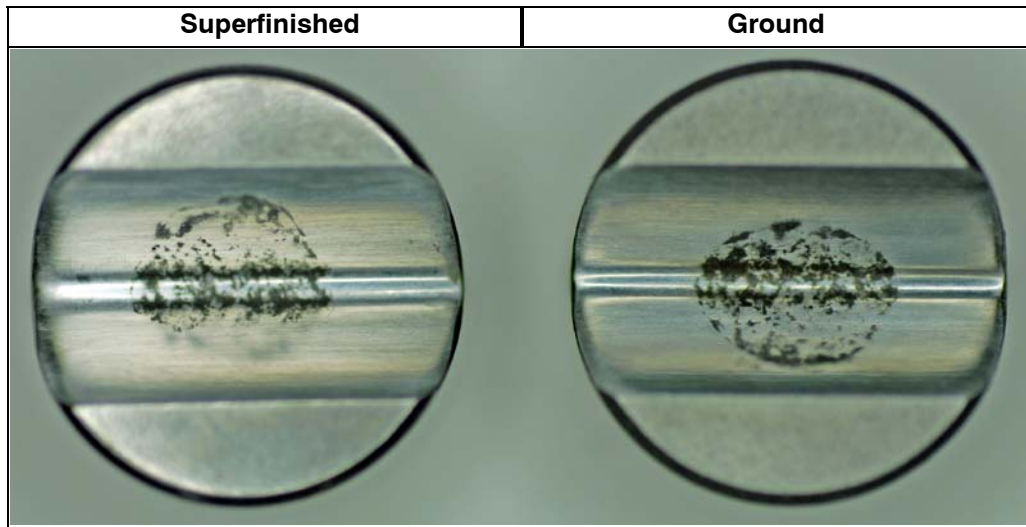
This layer was mechanically removed; the V-Block was polished with 1500-grit paper to remove the greater part of the corrosion deposits. The surface was then cleaned with #0000 steel wool followed by ultrasonic cleaning in a mild caustic cleaning solution. Pitting corrosion, crevice corrosion, and IGA were observed on both the superfinished surface and ground surface. See Figures 7 and 8.

Figure 7. View 3 - Superfinished (L) and ground (R) after mechanical cleaning, showing residual corrosion

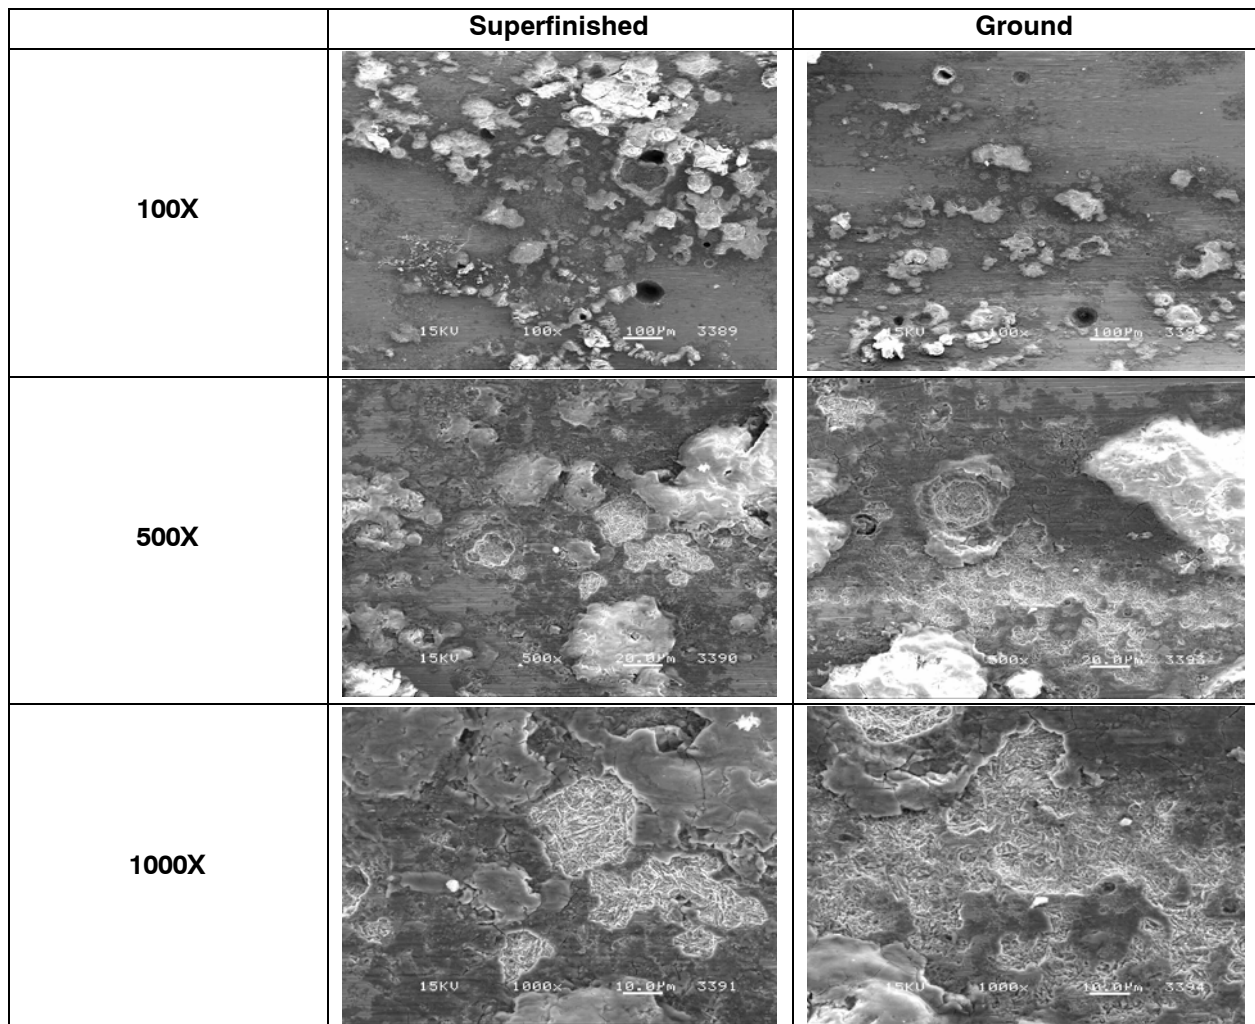
Figure 8. SEM images of test specimens after mechanical cleaning. Superfinished (L) and ground (R). Deep pits are visible in the 100X images. The white deposits cover shallower pits. IGA cracks are visible in the 1000X images.

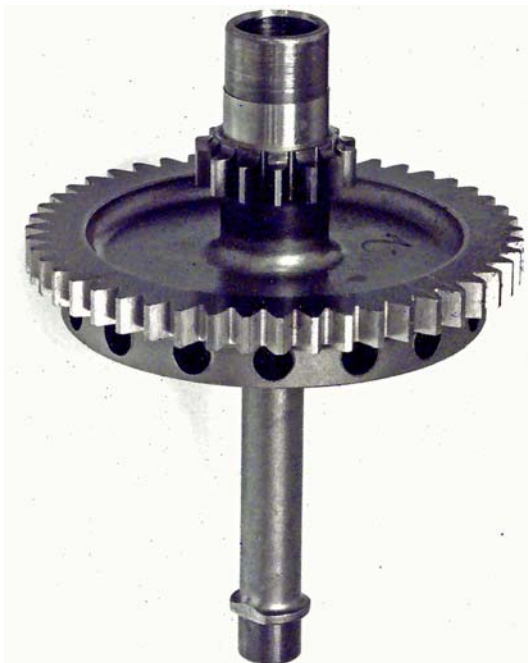
In 2000, Rolls-Royce Corporation sent used/scrap carburized AISI 9310 gasifier train gearshafts to REM Chemicals, Inc. for edge radiusing. See Figure 9. Initial inspection revealed light contact damage on the gear flanks.

**Figure 9. As received used/scrap carburized AISI 9310 gasifier train gearshaft**

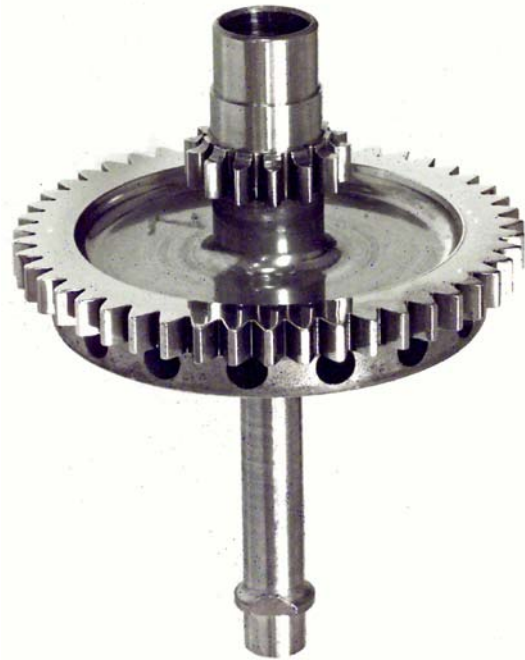
The gearshaft was superfinished using chemically accelerated vibratory finishing, as described elsewhere.[5] [6] See Figure 10.

**Figure 10. Superfinished used/scrap carburized AISI 9310 gasifier train gearshaft**

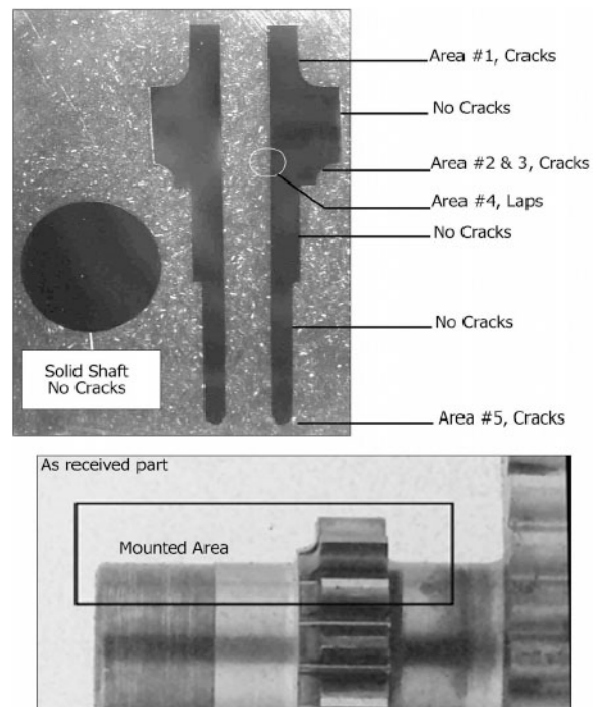
**Figure 11. Locations of IGA and contact damage on gearshaft sections (Top) taken from the gearshaft (Bottom)**

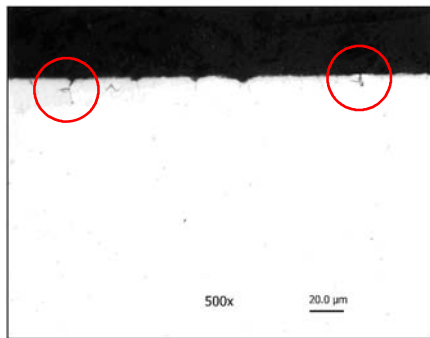
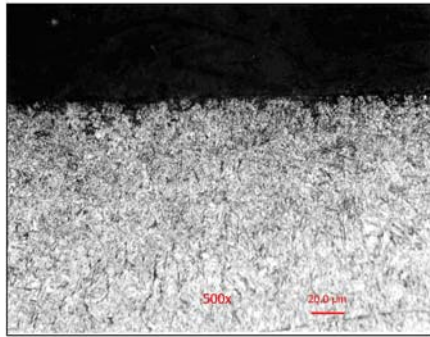
**Figure 12. Photomicrographs of Area 1 at 500X magnification. Circles show several IGA cracks.**

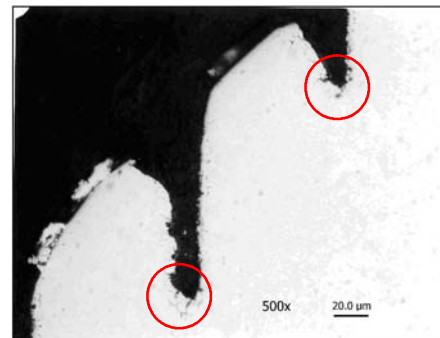
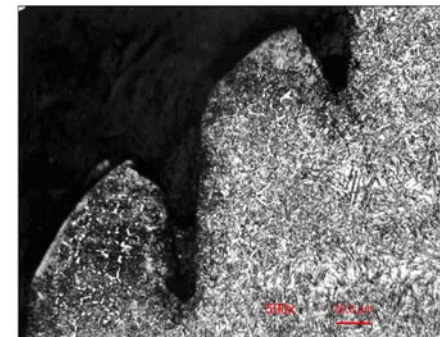
**Figure 14. Photomicrograph of Area 3 at 500X magnification. Circles show visible IGA cracks in the valleys of the machining lines**

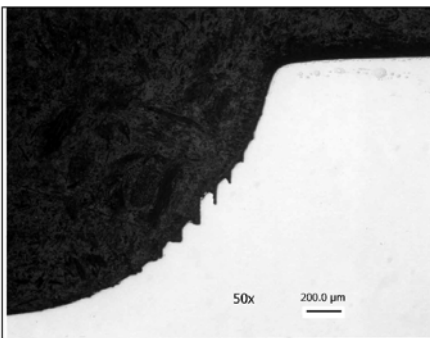
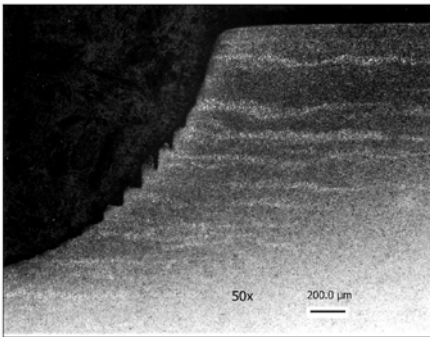
**Figure 13. Photomicrographs of Area 2 at 50X magnification showing residual machining lines**

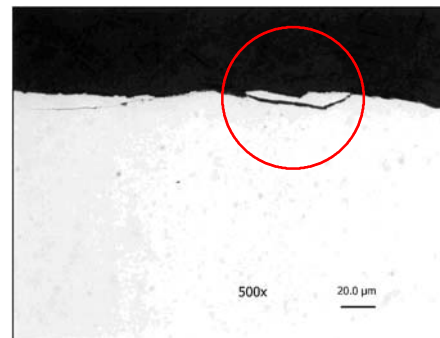
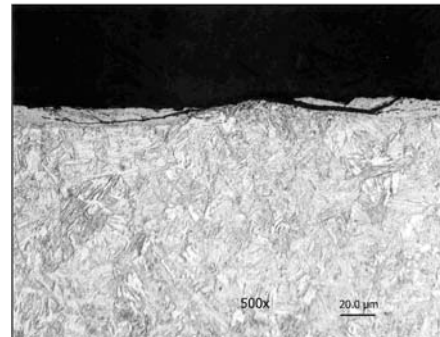
**Figure 15. Photomicrograph of Area 4 at 500X magnification showing contact surface damage**

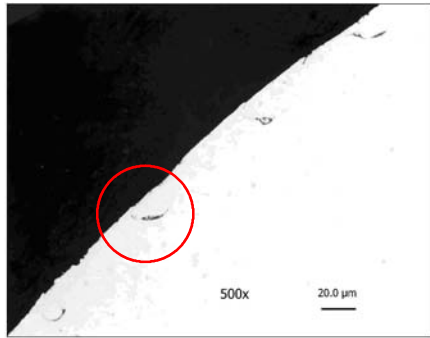
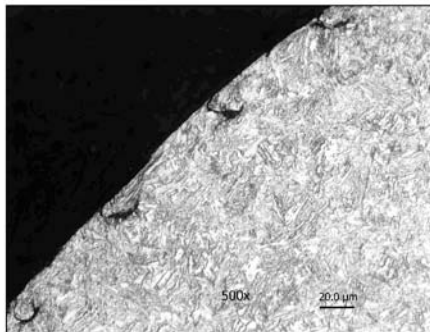
**Figure 16. Photomicrograph of Area 5 at 500X magnification. Circle shows contact surface damage**

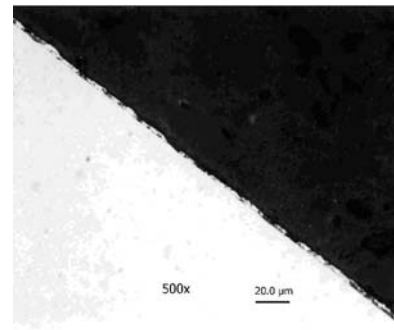
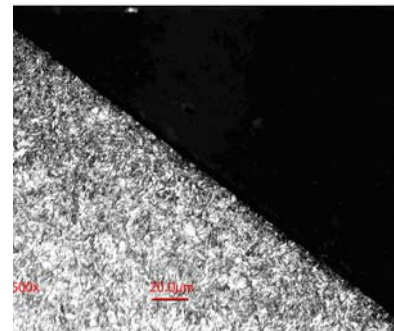
In order to demonstrate that the superfinishing process did not cause IGA, a Falex 9310 V-Block was superfinished under the same conditions as the AISI 9310 gearshaft. The V-Block was sectioned, polished and the V-area was examined. The photomicrographs showed no IGA or pitting. See Figure 17. This definitively confirmed that superfinishing does not induce IGA.

**Figure 17. Photomicrograph of the V-Area of the superfinished V-Block at 500X magnification. No pitting or IGA was detected.**

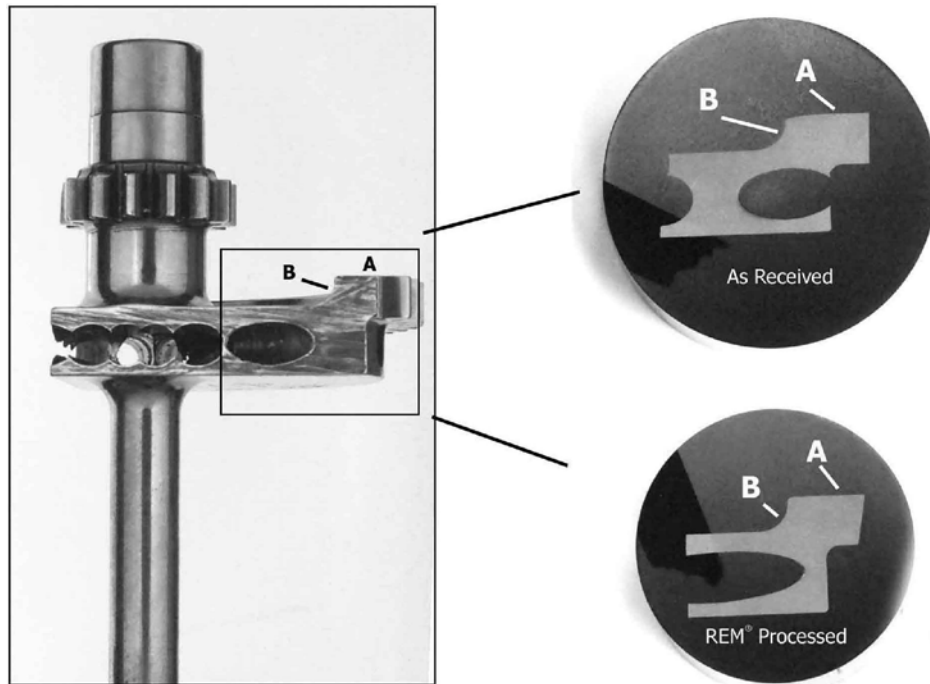
Rolls-Royce Gasifier Train Gearshaft

**Figure 18. Cross section of gearshaft studied to determine the effect of superfinishing on IGA. IGA was detected on areas A & B**

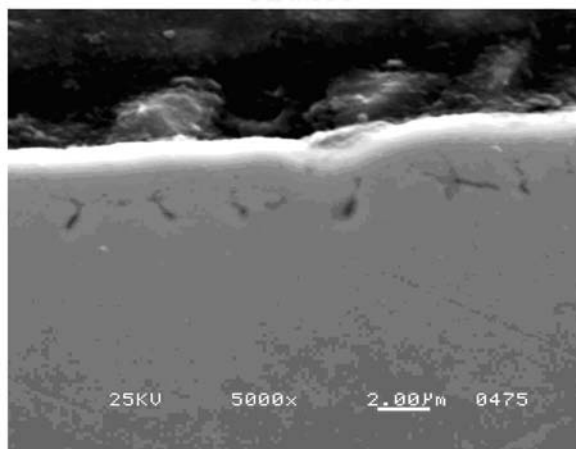
The gearshaft was sectioned, polished, and examined. SEM images confirmed the presence of IGA. See Figure 19. The maximum nominal depth of the IGA was 0.0002".

**Figure 19. SEM at 5000X magnification, showing the presence of IGA. Circle shows a typical IGA crack on areas A & B. The nominal IGA depth is 0.0002"**

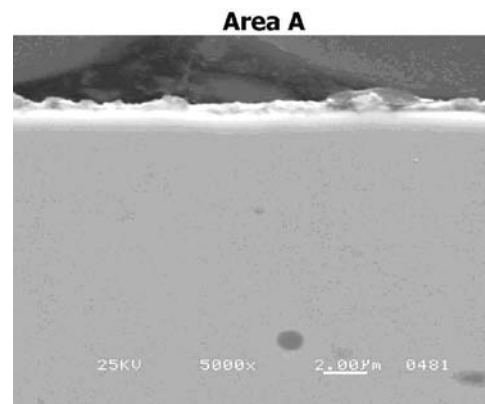
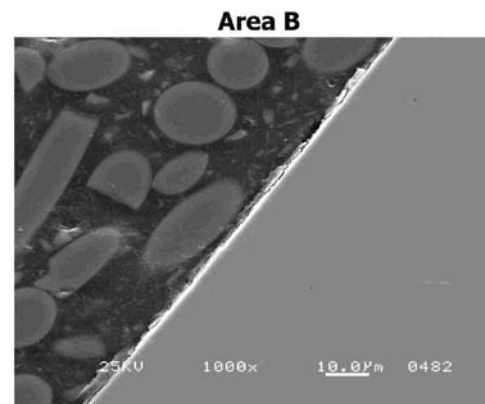
**Figure 20. SEM images of Areas A and area B showing that superfinishing removed the IGA**

The gearshaft was then superfinished such that approximately 0.0002" of metal stock was removed. It was then sectioned, polished, and examined for the final inspection. The SEM image clearly shows that the layer containing the IGA was completely removed. See Figure 20. The surface at 5000X shows that it is extremely smooth. This proved that the superfinishing process is not only metallurgically safe, but is also capable of repairing damaged surfaces. However, the depth of the damage must not exceed the metrological tolerance limits of the gear teeth.
