10FTM03

## **AGMA Technical Paper**

# **A Novel Approach to the Refurbishment of Wind Turbine Gears**

By M. Michaud, REM Surface  
Engineering, G.J. Sroka and  
R.E. Benson, REM Research  
Group

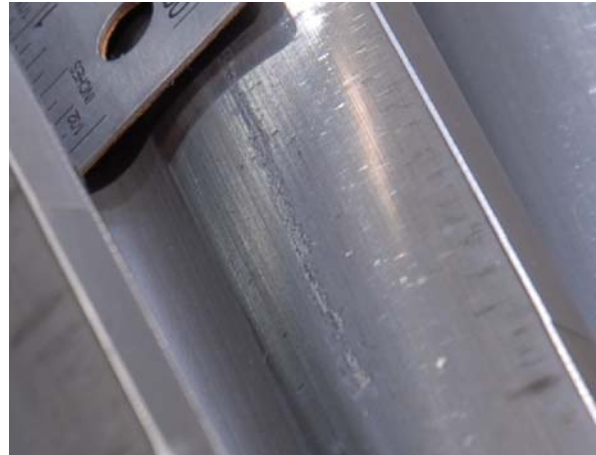
Figure 1a. Micropitting or gray staining on gear flanks

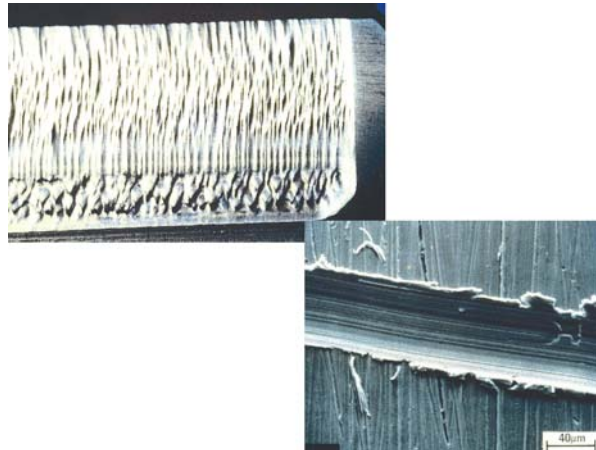
Figure 1b. Heavy abrasive wear on gear flank and a SEM image of trail left by an abrading particle [4]

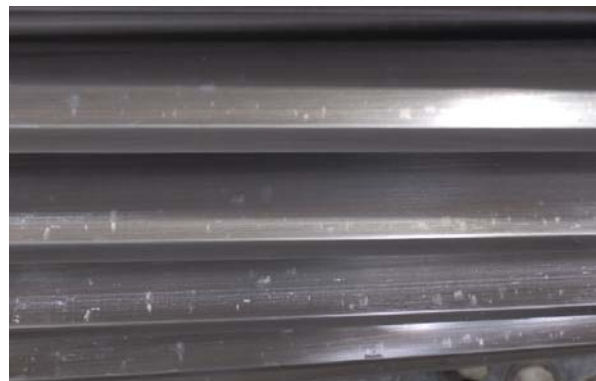
Figure 1c. Foreign object debris (FOD) damage

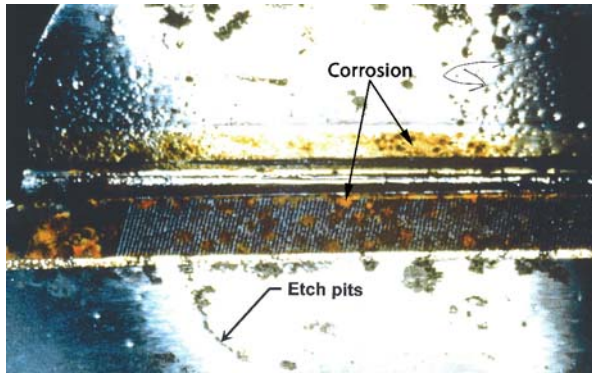
**Figure 1d. Corrosion looking down on top land [4]**

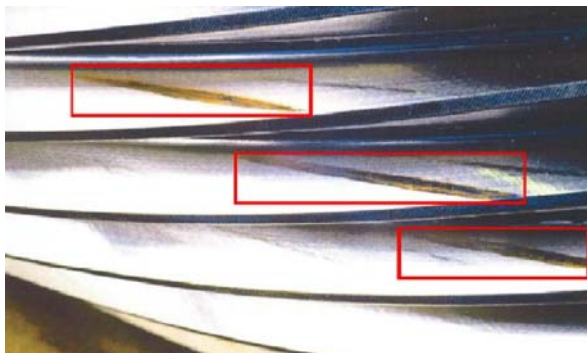
**Figure 1e. Fretting corrosion [4]**

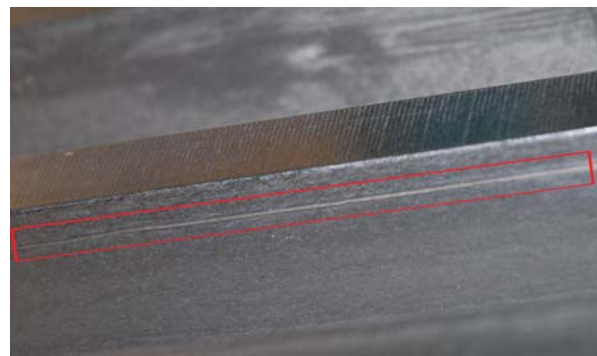
gears. There is sufficient material removal to reveal subsurface damage from micropitting, scuffing and corrosion that may be masked by the texture of the used surface. Grinding and in-service wear may cause a “smearing” of the metal on the gear surface resulting in subsurface damage not only being invisible to the naked eye, but also potentially going undetected by other inspection methods [11]. For example, Figure 4 depicts a cracked gear tooth that was delivered by a customer and deemed suitable for refurbishment. Only after superfinishing did the crack become visible. Consequently, this gear was scrapped and the potential catastrophic failure of the gearbox was avoided. In general, superfinishing can.

**Figure 4. Crack on a used gear near the addendum of the tooth was revealed only after superfinishing**

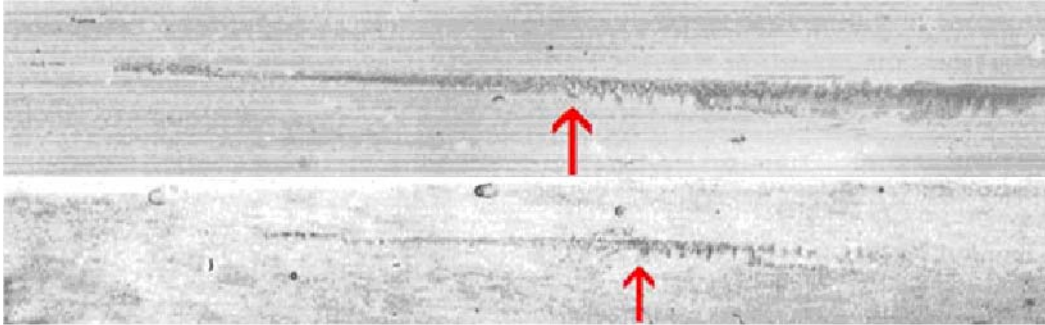
6. Superfinishing can also remove light ( $\leq 25 \mu\text{m}$  depth) to moderate ( $\leq 130 \mu\text{m}$  depth) damage from the gear tooth surface while maintaining geometric tolerances. Figure 5 shows images of the graphite tape lift method that is used to measure and record the amount of micropitting on a gear flank [12]. The deepest micropitting damage is approximately 150  $\mu\text{m}$  (see arrows). In this instance, it is apparent that some micropitting remains after superfinishing. The removal of all damage may have compromised the geometry of the gear. However, the peak asperities or “stress raisers” were removed and the existing micropitting will, in all likelihood, not progress to pitting and eventual spalling [13]. Recently, gearbox manufacturers indicated between 150-250  $\mu\text{m}$  can be safely removed without compromising the gear geometry.<sup>1</sup>

**Figure 5. Graphite tape lifts from damaged gear surface before (top) and after (bottom) superfinishing refurbishment**

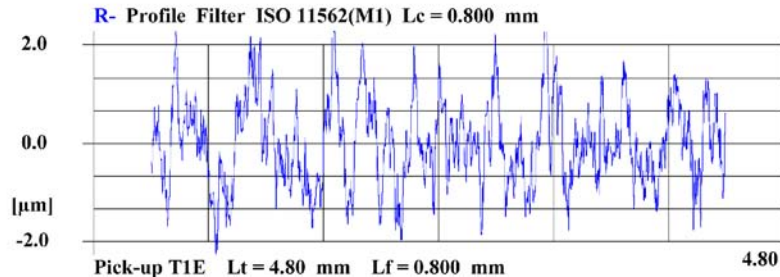
**Figure 6b. Surface trace of a used low-speed stage pinion before superfinishing (2308)**

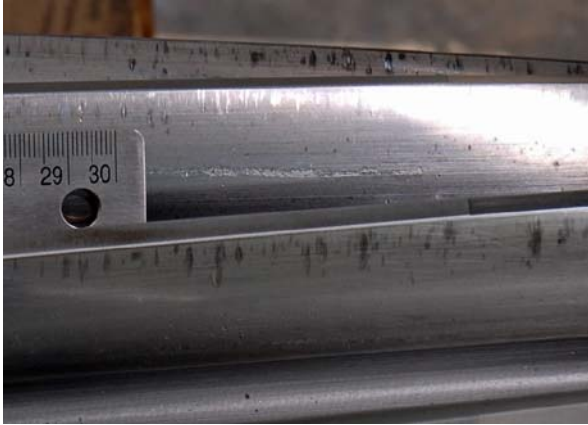
**Figure 8a. Sun pinion gear with several modes of damage including hard line micropitting**

1. After the gear was received it was inspected for damage. Micropitting and light abrasive wear were noted. Pre-finishing inspection is crucial as gears may be damaged during decommissioning and/or transport.
2. The initial average surface roughness ( $R_a$ ) was measured to be  $0.31 \mu\text{m}$ . Refer to Table 1.
3. The gear was placed in a vibratory finishing apparatus with an optimized media mixture to effect uniform stock removal on the flank.

4. It was processed in active chemistry for a short duration and then carefully inspected for hidden serious damage such as cracks or deep pitting. No serious damage was detected.
5. The gear was further processed in active chemistry and its surface roughness was periodically monitored with a skidded portable profilometer<sup>2</sup> until the targeted  $R_a$  was achieved.
6. The pinion was then burnished to remove all traces of the conversion coating.
7. The  $R_a$  of the superfinished refurbished gear was determined to be  $0.07 \mu\text{m}$ . Refer to Table 2.

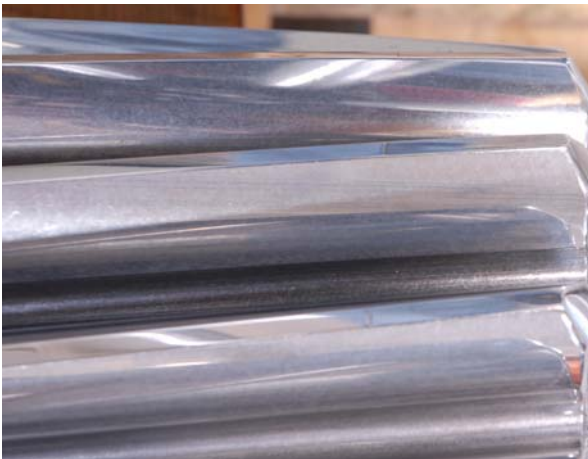
**Figure 8b. The same sun pinion gear after refurbishment**
