## The state of the art of wind turbine gearboxes

Regularly scheduled maintenance keeps turbines spinning, and the proper lubricants can extend the period between checkups.

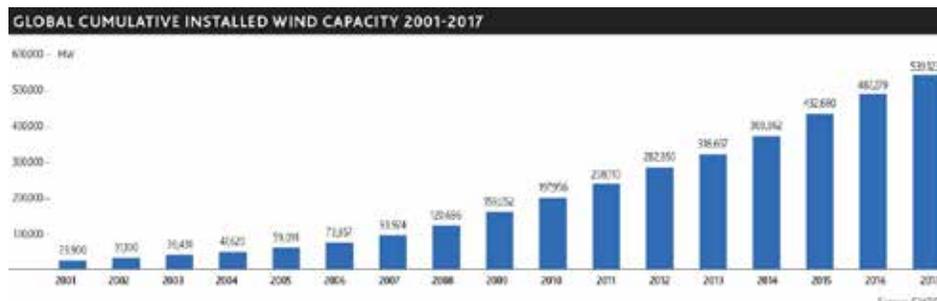
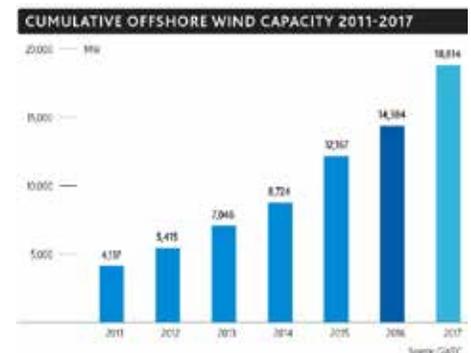
Figure 1: Installed global wind capacity in megawatts (above). Figure 2: Cumulative offshore capacity in megawatts (right). (Global Wind Energy Council)

**M**uch has been written here about the global growth in the wind turbine industry. Today, more than 341,320 wind turbines are operating worldwide. In particular, the number of offshore installations has exploded in the past seven years (Figures 1-2).

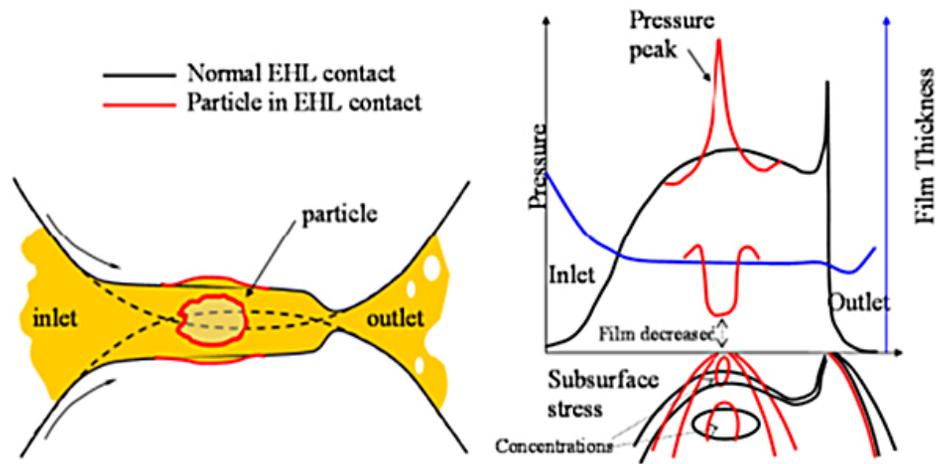
Figure 3: Schematic of a contact zone containing a hard metal particle and its resulting pressure peak.

metal particles rapidly clog the filters if they are large enough to be captured. Unfortunately, many are too small to be filtered out. These unfilterable small particles, typically 1-5 microns in size, create numerous lubricant problems. For instance, very large pressure peaks are produced when a small hard metal particle passes through the contact zone of a gear or bearing, as represented in Figures 3-4. Along with denting or abrading the tribological surface of the given component, which leads to a further increase in mixed EHL, the particles result in high pressure peaks which accelerate the surface fatigue of the gear or bearing. In fact, some experts believe the high pressure peaks from metal particles in bearing contacts lead to or contribute to the problem of axial fatigue cracking in today's wind turbine industry (T. Stalin; Vattenfall; NREL/GRC presentation February 2018).

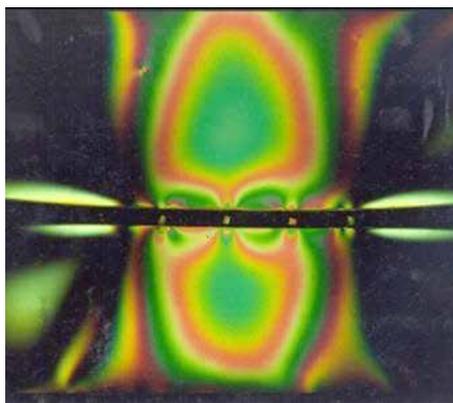
Figure 4: Image of the pressure peak caused by a hard particle in a contact zone.

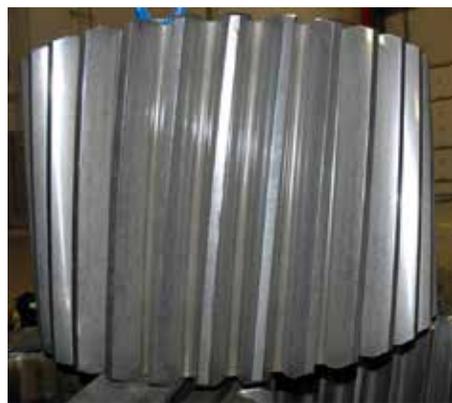
Figure 5: Three multi-megawatt class isotropic superfinished planets removed after seven years of operation.

Figures 5-6 depict a set of multi-mega wind turbine planets that were originally isotropic superfinished by the manufacturer. The “galvanized” tooth surface appearance is the normal burnished appearance. These planets had been removed after seven years of operation for bearing maintenance and were returned to operation without any repair. Note there is no metal to metal contact pattern on the tooth flanks. This is proof that these isotropic superfinished planets were, and are continuing to operate, in full EHL. In other words, the planet teeth are not rubbing against the sun pinion or annulus teeth and no iron particle debris is being generated.

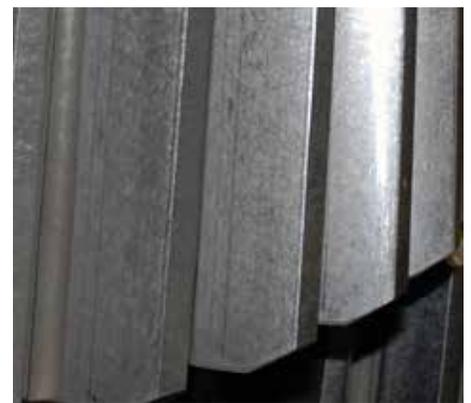
Figure 6: Closeup of the top planet after seven years showing no metal to metal contact pattern.
