10FTM03

## **AGMA Technical Paper**

# **A Novel Approach to the Refurbishment of Wind Turbine Gears**

By M. Michaud, REM Surface  
Engineering, G.J. Sroka and  
R.E. Benson, REM Research  
Group

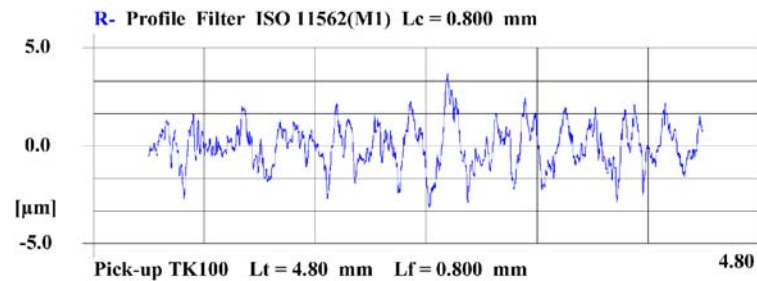
tests, the repaired gears met or exceeded the performance of the new gears”. Figure 6 depicts profilometer traces of (a) new ground gear, (b) used gear prior to refurbishment and (c) used gear after refurbishment via superfinishing.

**Figure 6a. Surface trace of a new ground low-speed stage pinion before superfinishing (2282)**

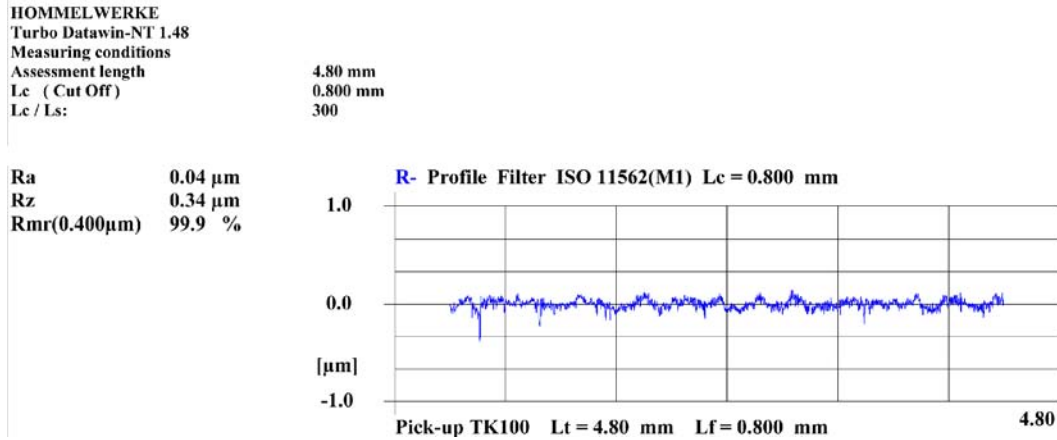
**Figure 6c. Surface trace of low-speed stage pinion after superfinishing (2282)**

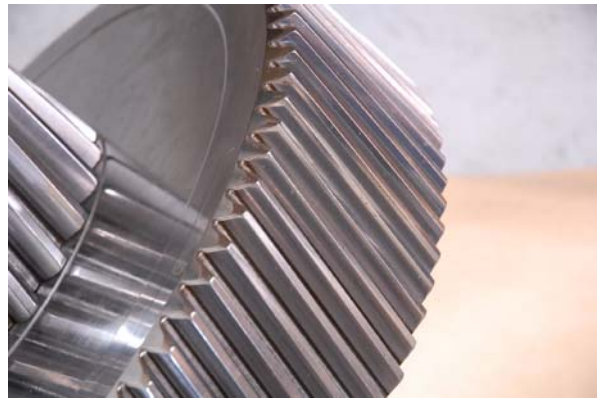
**Figure 7a. Superfinished intermediate gear assembly**  
(photo courtesy of Moventas)

1. The process does not require engineering drawings.
2. All teeth are uniformly and simultaneously finished. For example, the cost per tooth is the same for a small gear with 59 teeth versus a large gear with 113 teeth.
3. As described superfinishing requires less setup time and potential complications versus grinding. Consequently, the turnaround time is rapid.
4. Typically the ring, sun and pinion gears of the low-speed stage and the output pinions of the high speed stage receive the most wear and are refurbished. However, the gears of the intermediate stage especially an assembled intermediate unit also can be superfinished with little additional expense since the entire gearbox is removed for maintenance. Figure 7 depicts a refurbished assembled intermediate stage gear.

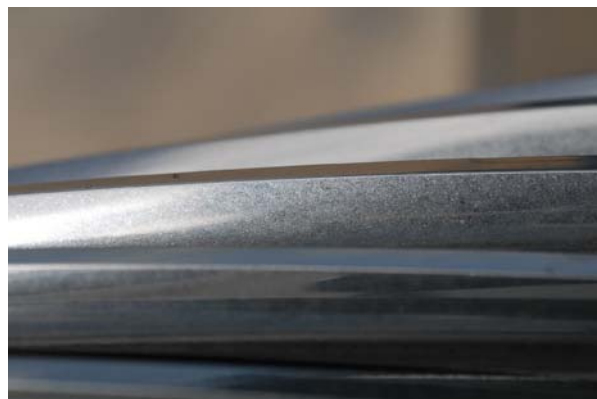
**Figure 7b. Characteristic Isotropic Superfinish on the flanks of the intermediate gear assembly pictured above**  
(photo courtesy of Moventas)
